Article in *Arabian Journal of Geosciences* · June 2020

Contradictive mining–induced geocatastrophic events at open pit coal mines: the case of Amintaio coal mine, West Macedonia, Greece

Constantinos Loupasakis¹

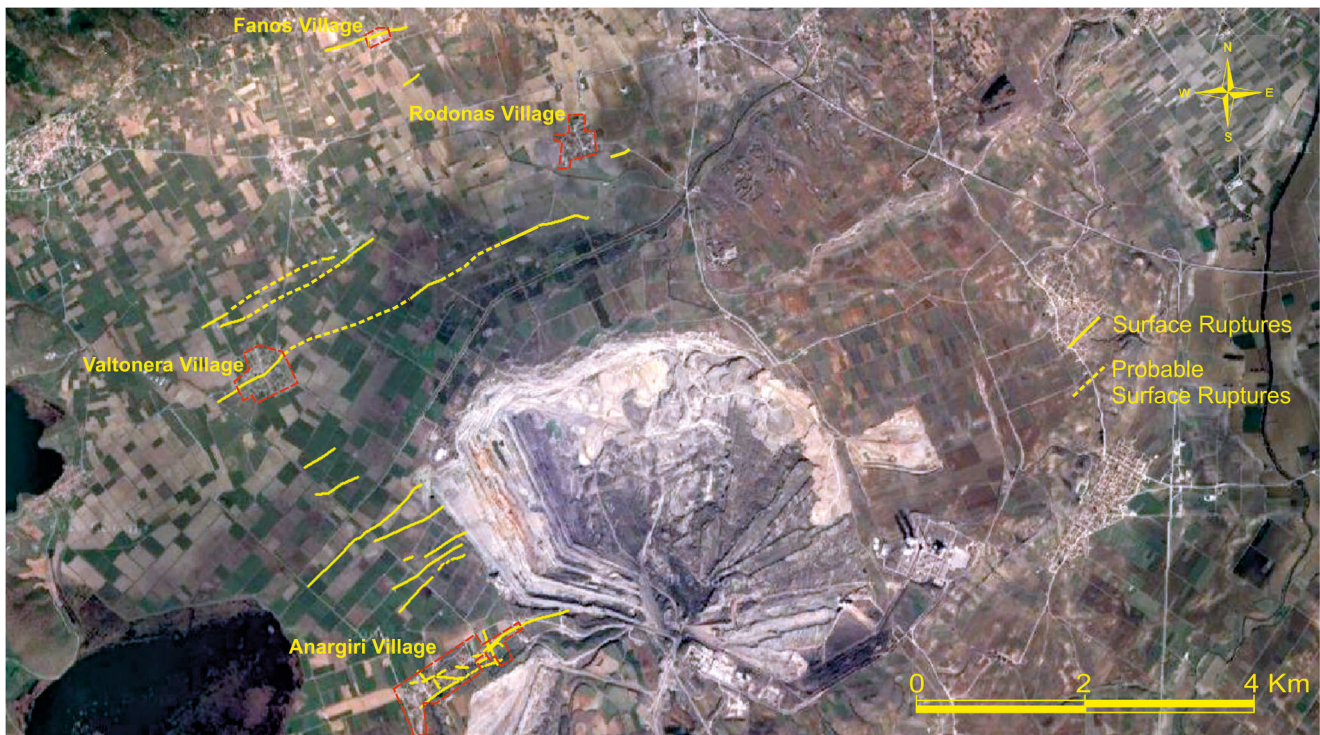
Fig. 5 Spatial distribution of the surface ruptures at the perimeter of the Amyntaio opencast mine before the occurrence of the slope failure (updated by Loupasakis et al. 2014; Tzampoglou and Loupasakis 2016)

In recording the surface ruptures generated in the plain area after the failure, it was interesting to note that some of them followed older ruptures generated by the land subsidence phenomenon. As presented in Fig. 5, during the years before the failure, some limited surface ruptures had developed at Anargiri village parallel to the piezometric contour lines of the depression cone, following an E-W direction. As it appears in Fig. 11, those ruptures were subjected to intensive deformations after the occurrence of the landslide, indicating that their reduced shear strength made them disposed towards displacements after the activation of the landslide. Overall, despite the fact that the fault lines affected the mechanisms of the two catastrophic events in different ways, the generated surface ruptures seem to interact with each other, amplifying the differential displacements at the site.

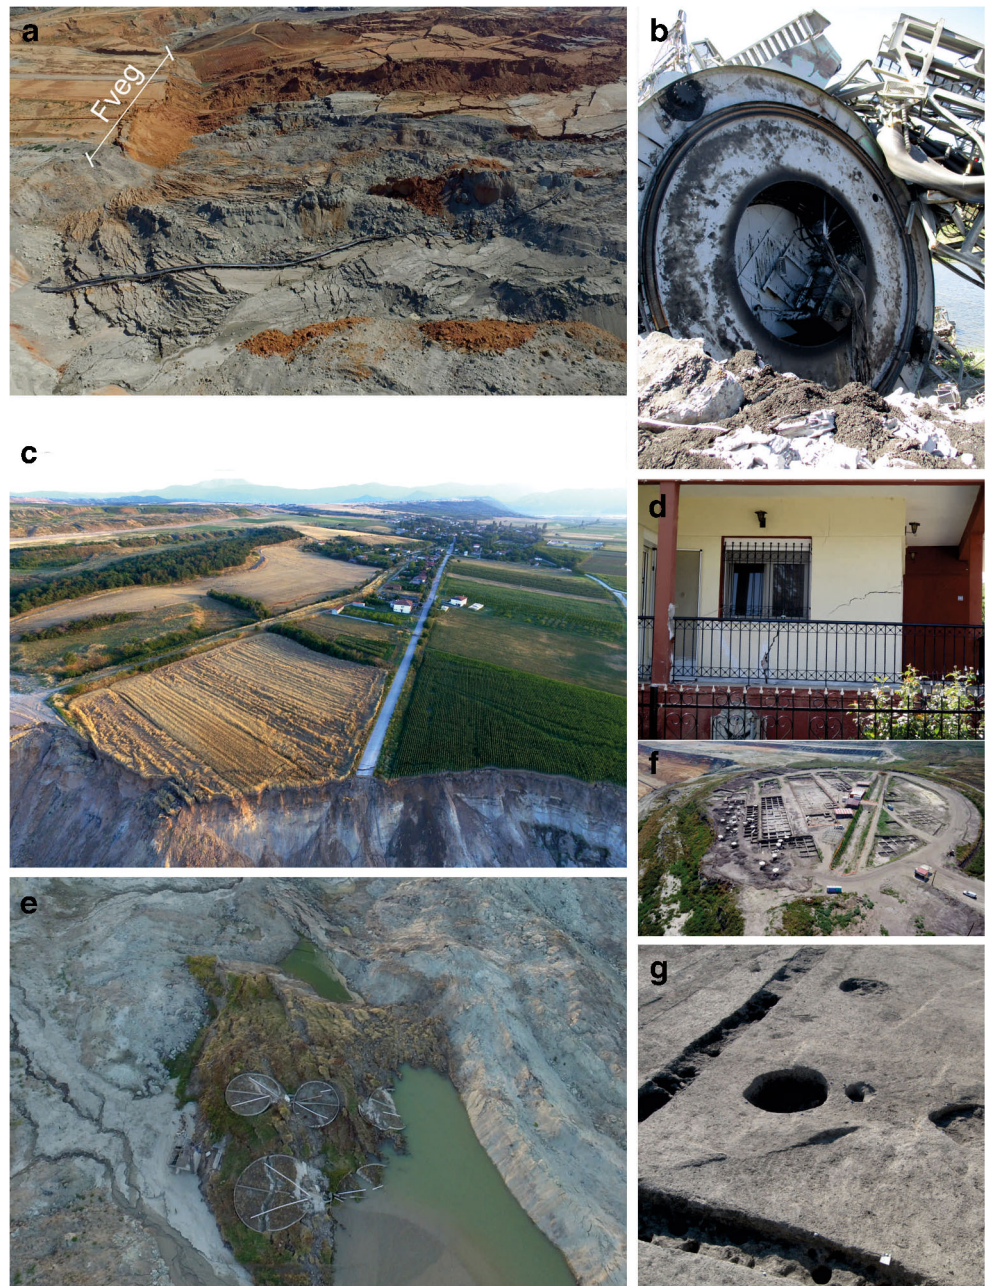
Fig. 7 **a** A closer view of the western boundary of the landslide. Several meters of destroyed conveyor can be identified. The part of the outline coinciding with a segment of the Vegoritida fault is clearly indicated. **b** A 1500-ton bucket wheel excavator buried by the landslide. **c** A view of the part of Anargiri village affected by the landslide. The destroyed road network is also clearly presented. **d** One of the houses in Anargiri village damaged by the landslide. **e** The wastewater treatment plant of Anargiri village collapsed inside the open cast. **f** One of the archeological sites of the lacustrine Neolithic settlements located at the perimeter of the open cast before the occurrence of the landslide. **g** A closer view of an archeological excavation. The preserved traces from the wooden piles used for the foundation of Neolithic houses are presented

80 million cubic meters, burying 25 million tons of lignite. The failure caused extreme damage to the portable and permanent infrastructure of the mine as well as to the nearby Anargiri village (Fig. 7). In particular, four bucket wheel

plant collapsed into the open cast, an entire neighborhood with houses up to two stories was damaged, the water supply and electricity infrastructure was destroyed, and the main roads connecting the village with the rest of the plain were severely damaged. In addition, several archeological sites of lacustrine Neolithic settlements located at the perimeter of the open cast were destroyed (Fig. 7).

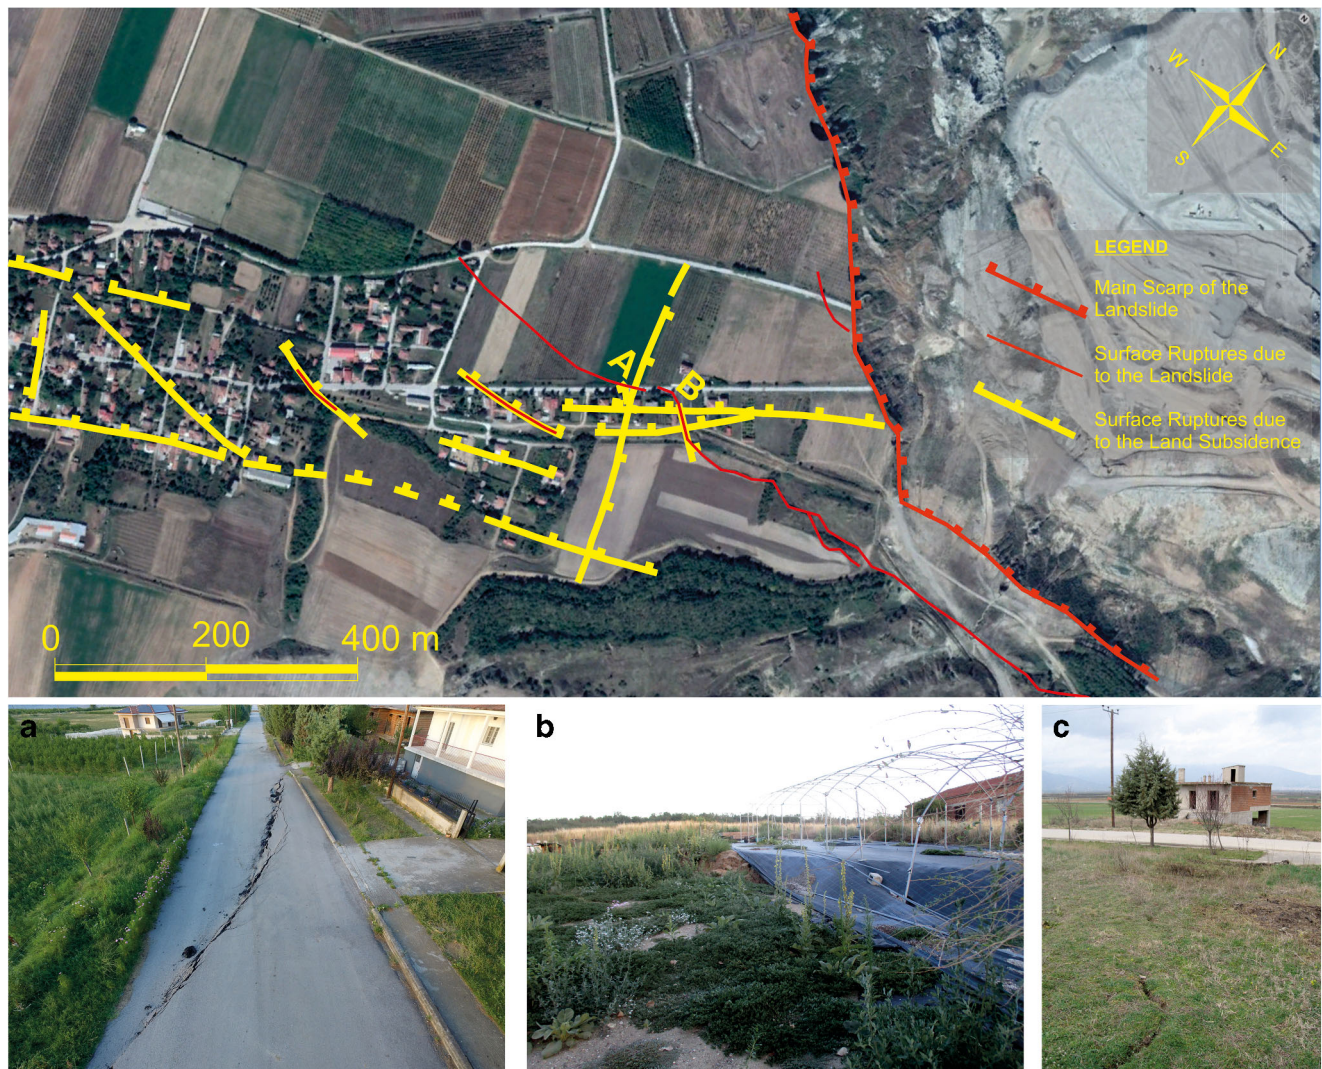
Fig. 11 The overlapping of the surface ruptures caused by the land subsidence phenomenon with those triggered by the landslide proves their interaction at the southwestern section of the working slopes. **a**, **b**

preexisting surface ruptures intensified by the landslide event. **c** the surface rupture shown in **b** as it was recorded before the occurrence of the landslide
